Seismic Response of Low-Rise Masonry Buildings With Flexible Roof Diaphragms

Gregory L. Cohen, Richard E. Klingner, John R. Hayes, Jr.,
and Steven C. Sweeney

August 2001

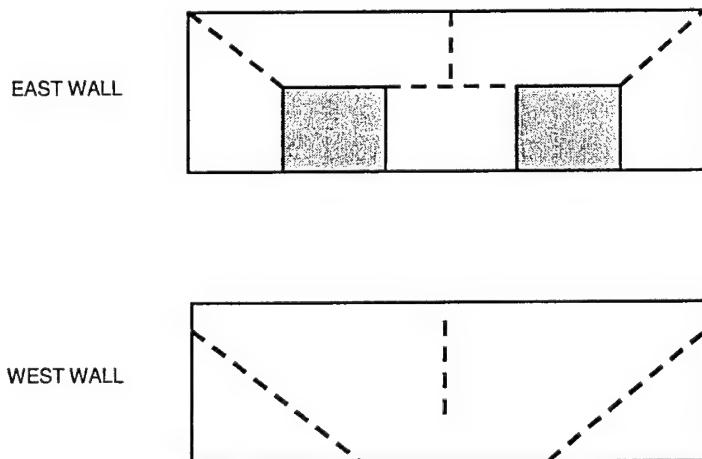
Visible and audible damage increased with increasing excitation. At input acceleration levels greater than 1.0g, cracking propagated throughout the structure along what became evident as out-of-plane yield lines. Figure 7.8 shows idealized yield lines for the longitudinal walls based on that observed cracking pattern. Also, the transverse walls developed prominent bed-joint cracks, characteristic of pier rocking (Figure 7.9). Figure 7.10 shows the actual cracking pattern for the perforated longitudinal wall. Visible damage finally occurred to the roof diaphragm during Test 10, at a maximum acceleration of 1.33g in the transverse direction. Inspection revealed some cracking at nailing points, and the end of one piece of sheathing lumber pulled loose. No other visible damage occurred to the diaphragm.

Figure 7.8. Probable yield lines of east perforated wall and west wall (Test 11, Specimen #1).

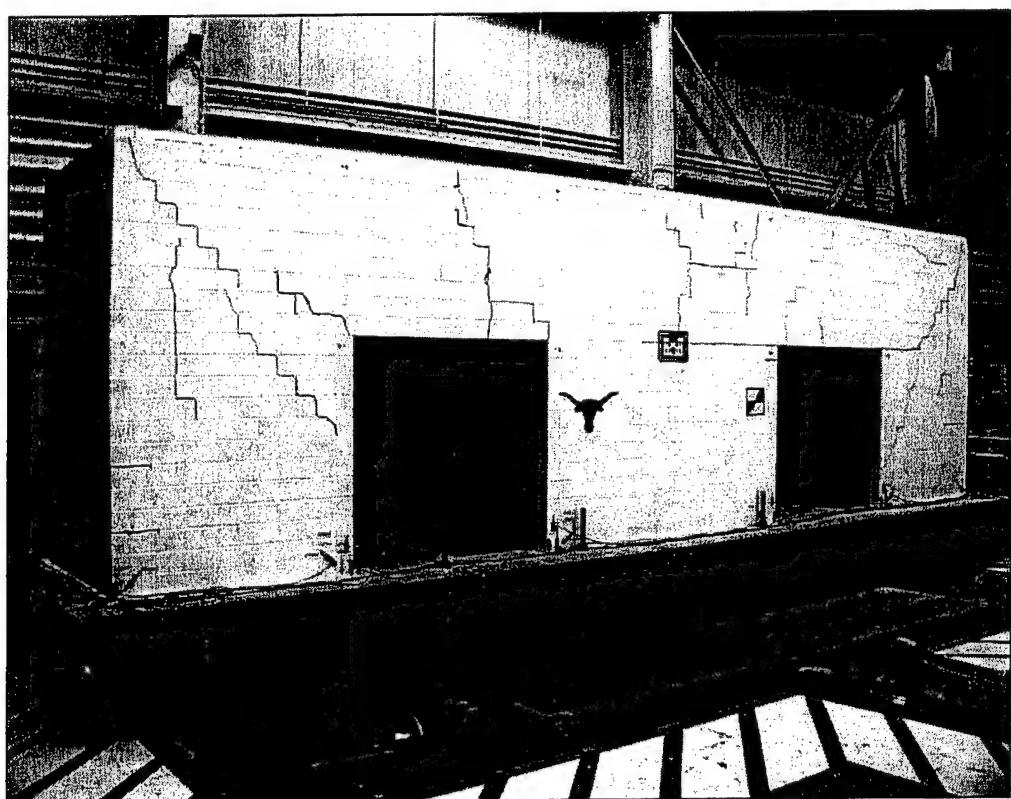
Figure 7.10. Actual cracking pattern of perforated wall (Test 11, Specimen #1).

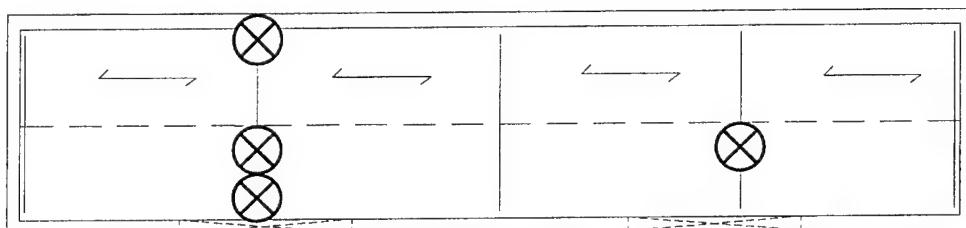
Visible and audible damage occurred during Test 8a with a peak longitudinal ground acceleration of 1.23g. Two puddle welds connecting the metal deck to the diaphragm fractured. Diaphragm damage increased with Test 8b and a peak longitudinal ground acceleration of 1.56g. During this test an additional puddle weld fractured and a shear crack formed above the north opening in the east longitudinal wall (Figure 8.9). The masonry walls sustained very little additional cracking, however.

Figure 8.8. Location of fractured puddle welds (Test 8b, Specimen #2).

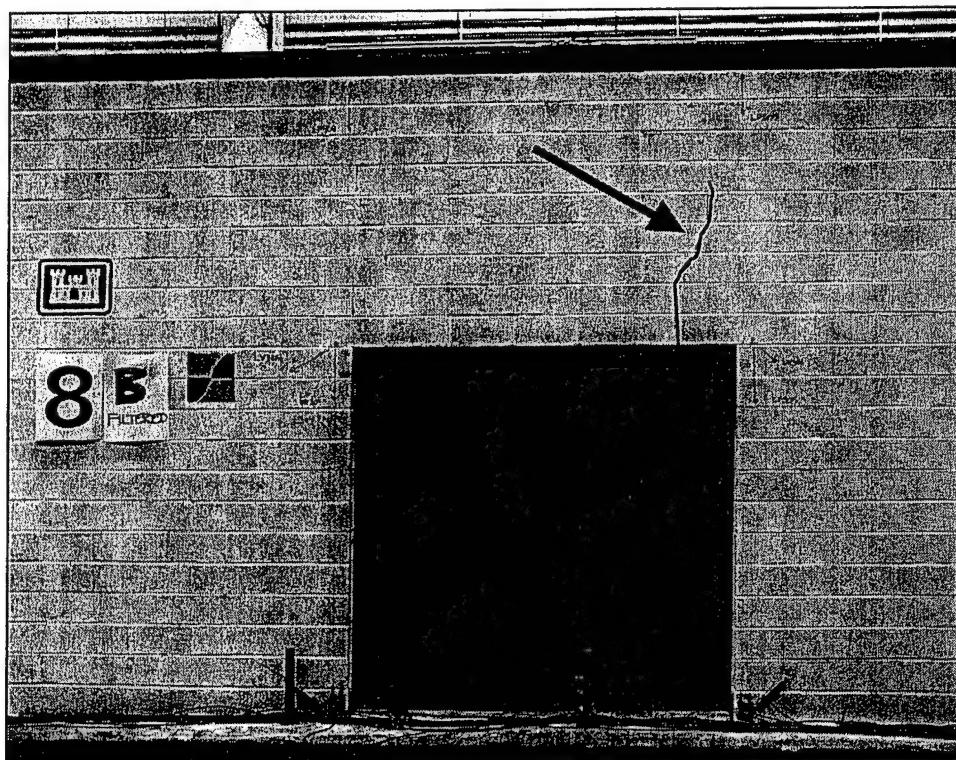
Figure 8.9. Shear crack above north perforation in east wall (Test 8b, Specimen #2).

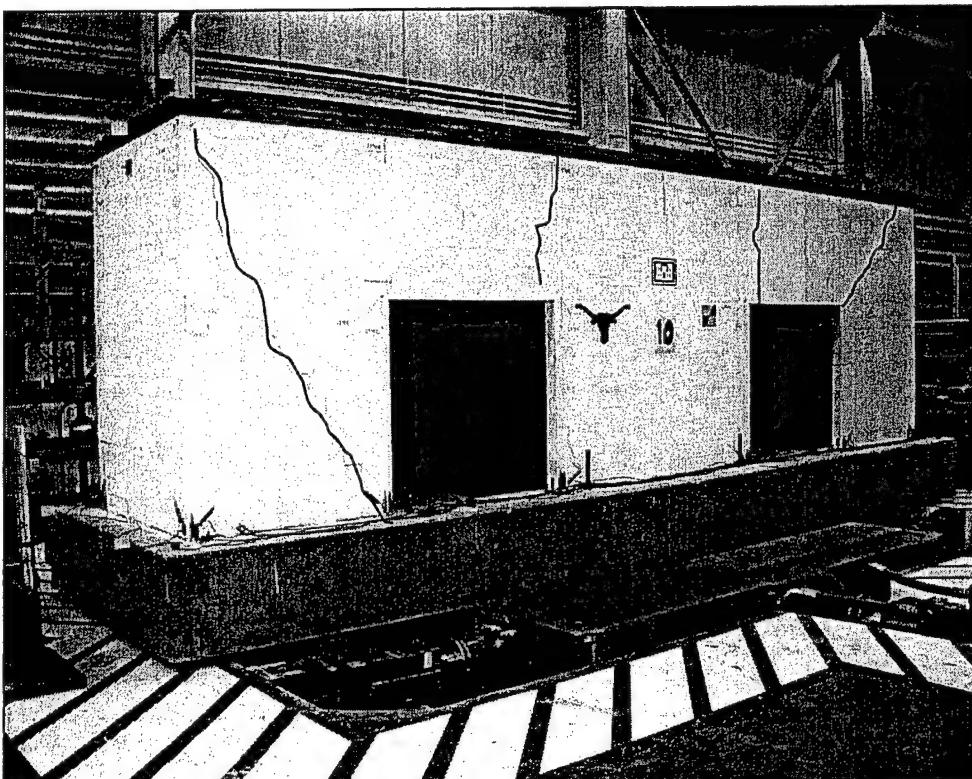
Damage spread quickly and extensively throughout the structure during strong transverse excitation. Cracking propagated through the structure along what became evident out-of-plane yield lines. Figure 8.12 shows idealized yield lines for the longitudinal walls. Figure 8.10 shows the actual cracking pattern for the perforated longitudinal wall.

Figure 8.10. Actual cracking pattern of east (perforated) wall (Test 10, Specimen #2).

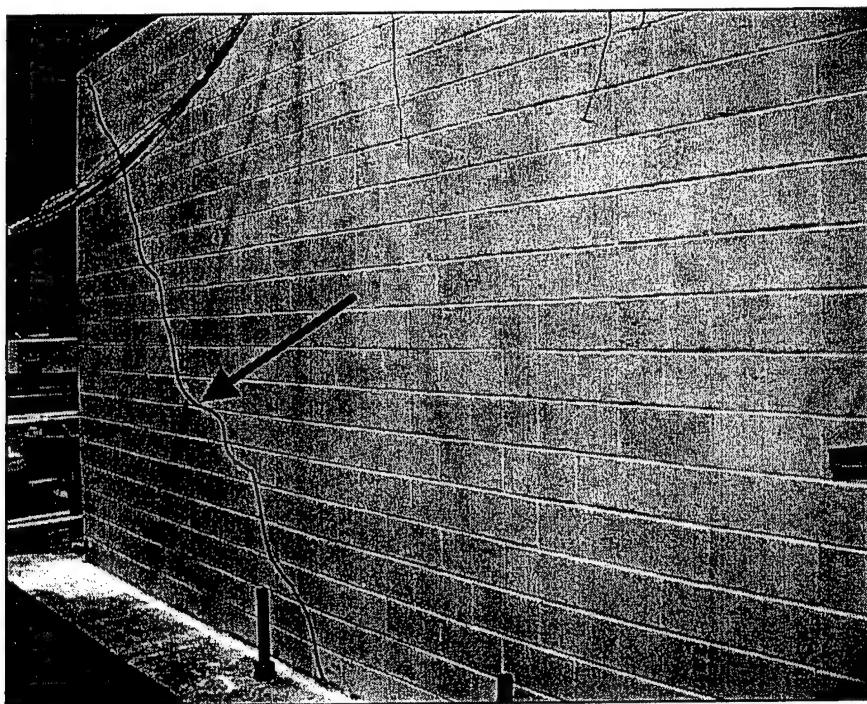
Figure 8.11. North end of west wall showing out-of-plane yield line (Test 10, Specimen #2).

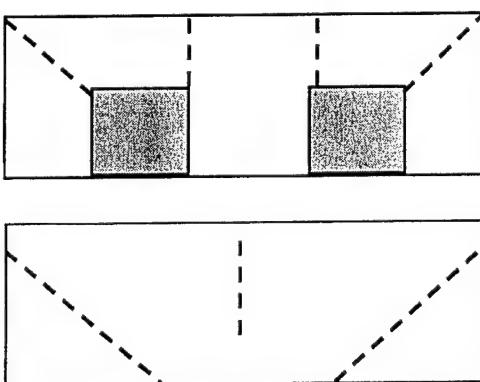
Figure 8.12. Probable yield lines of east (perforated) wall and west wall (Test 11, Specimen #2).

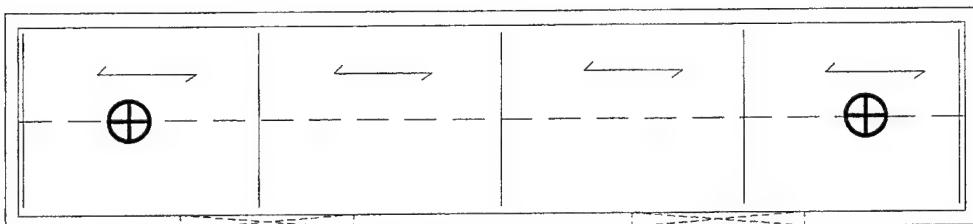
Extensive damage occurred to the roof diaphragm and diaphragm instrumentation during Test 10 at a maximum acceleration of $1.83g$ in the transverse direction. Inspection revealed that two side-lap screws at the north and south ends of the diaphragm had pulled out and subsequently severed several of the linear potentiometer wires running diagonally across the roof (Figure 8.1 and Figure 8.14). Furthermore, several of the linear potentiometers measuring end-lap slip and three of the five diaphragm accelerometers broke free from their mounts (Figure 8.3, Figure 8.6, Figure 8.14, and Figure 8.15).

Figure 8.13. Location of damaged side-lap screws (Test 10, Specimen #2).

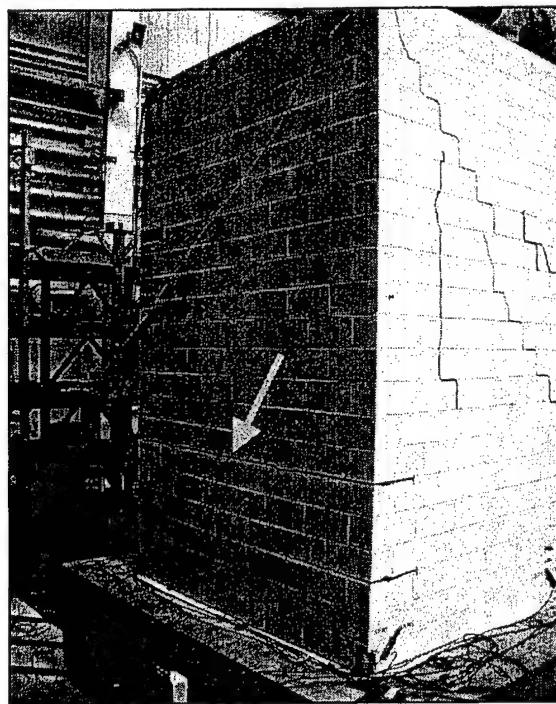
The transverse shear walls remained elastic during low levels of excitation, with no visible cracking or permanent deformation. This observation is substantiated by the fact that even at high input accelerations, wall drift ratios are less than 0.1 % (Equation 9-1 and Figure 9.10). During strong seismic tests ($\text{PGA} > 0.67\text{g}$) a continuous bed-joint crack developed along the entire plan length of the south shear wall (Figure 9.13). This crack was characteristic of rigid-body rotation of the shear wall about its base (wall rocking). Data from the vertical linear potentiometers on either side of the shear wall (Figure 7.1) confirmed the hypothesis of wall rocking (Figure 9.14). Closing of the bed-joint crack results in the sharp, downward peaks in the data. Opening of the bed-joint crack and eventual reversal of the direction of rotation of the wall causes the smoother, half-sinusoidal portions of the data record. The transverse shear walls sustained very little additional damage.

Figure 9.13. Bed-joint crack characteristic of wall rocking (Test 9, Specimen #1).

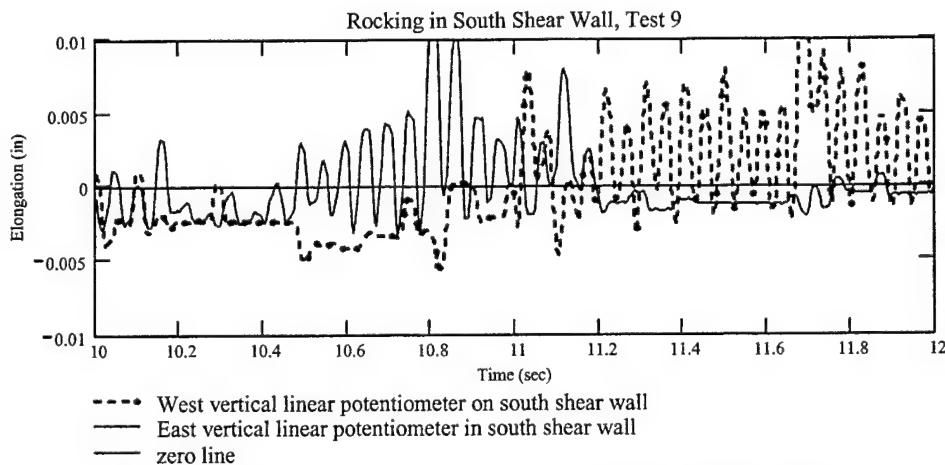
Figure 9.14. Rocking of south shear wall (Test 9, Specimen #1).
